Missouri La Forge  
Farms Project  
Unit 32

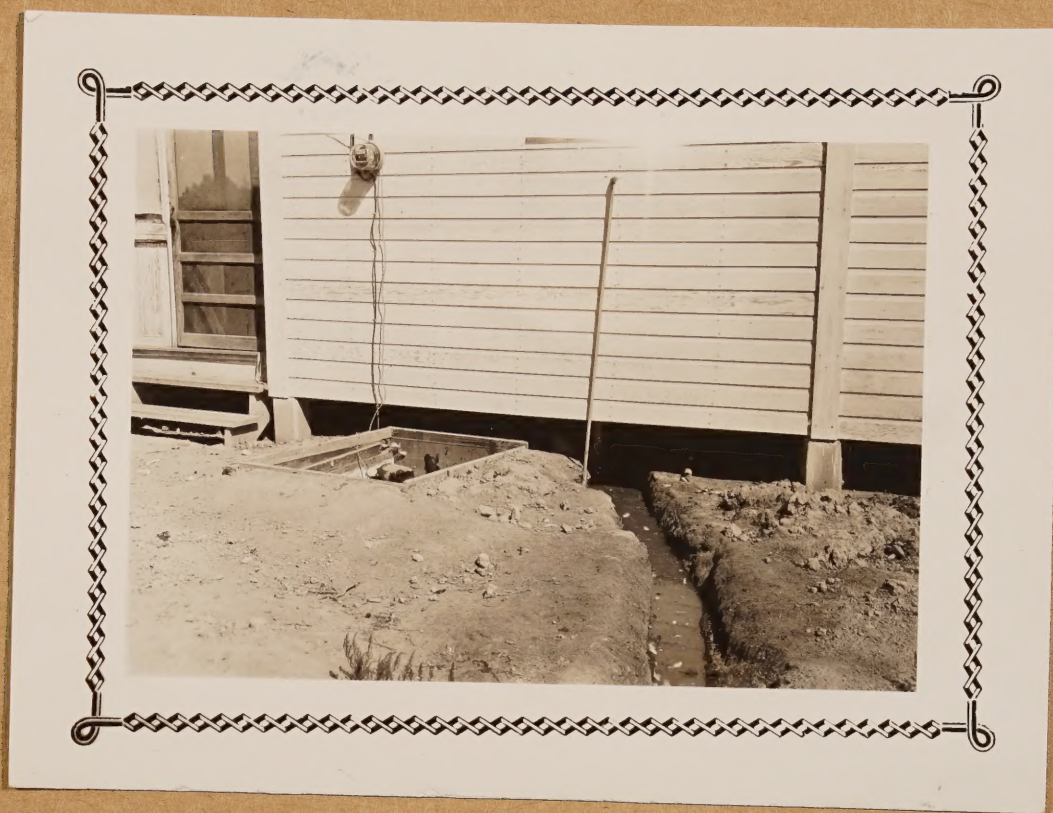
Another bad example of water system  
installation. Note: Lamp cord to motor;  
unprotected pipe up wall; waste water  
in open ditch, without proper drainage.  
Taken by: Jefferson B. Rodgers. 1941  
inadequate protection of water system.
